APPENDIX A: Analysis of Ignition Sources

APPENDIX B: Seismology Report

Introduction

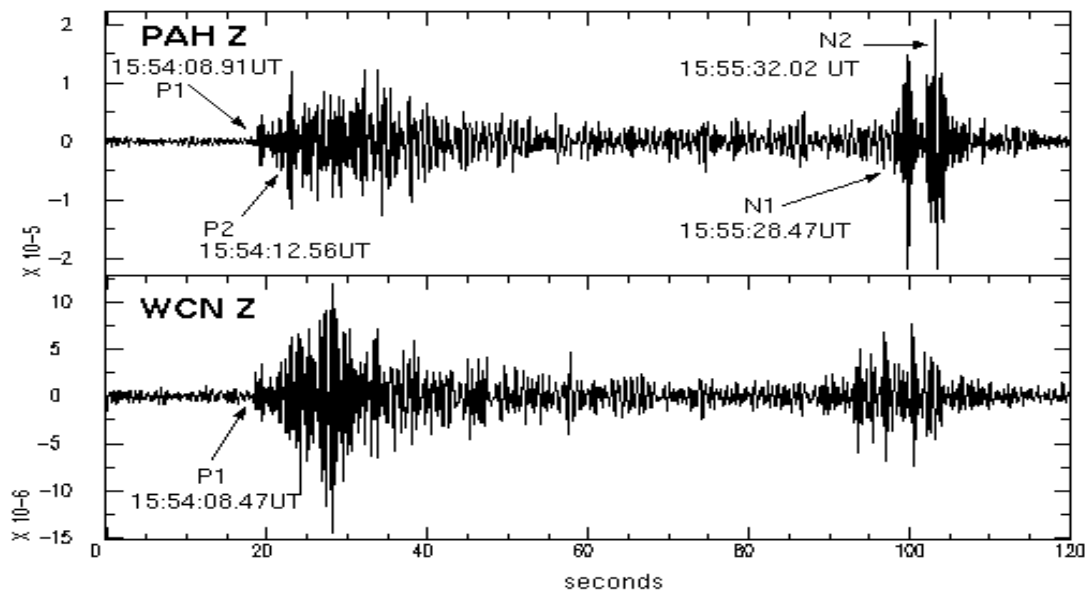
Figure 2a. Vertical component seismograms from station PAH and WCN. The P1 and P2 labels indicate P-wave arrivals for explosion A and B. N1 and N2 labels indicate the N-wave (air wave) arrivals for explosion A and B.

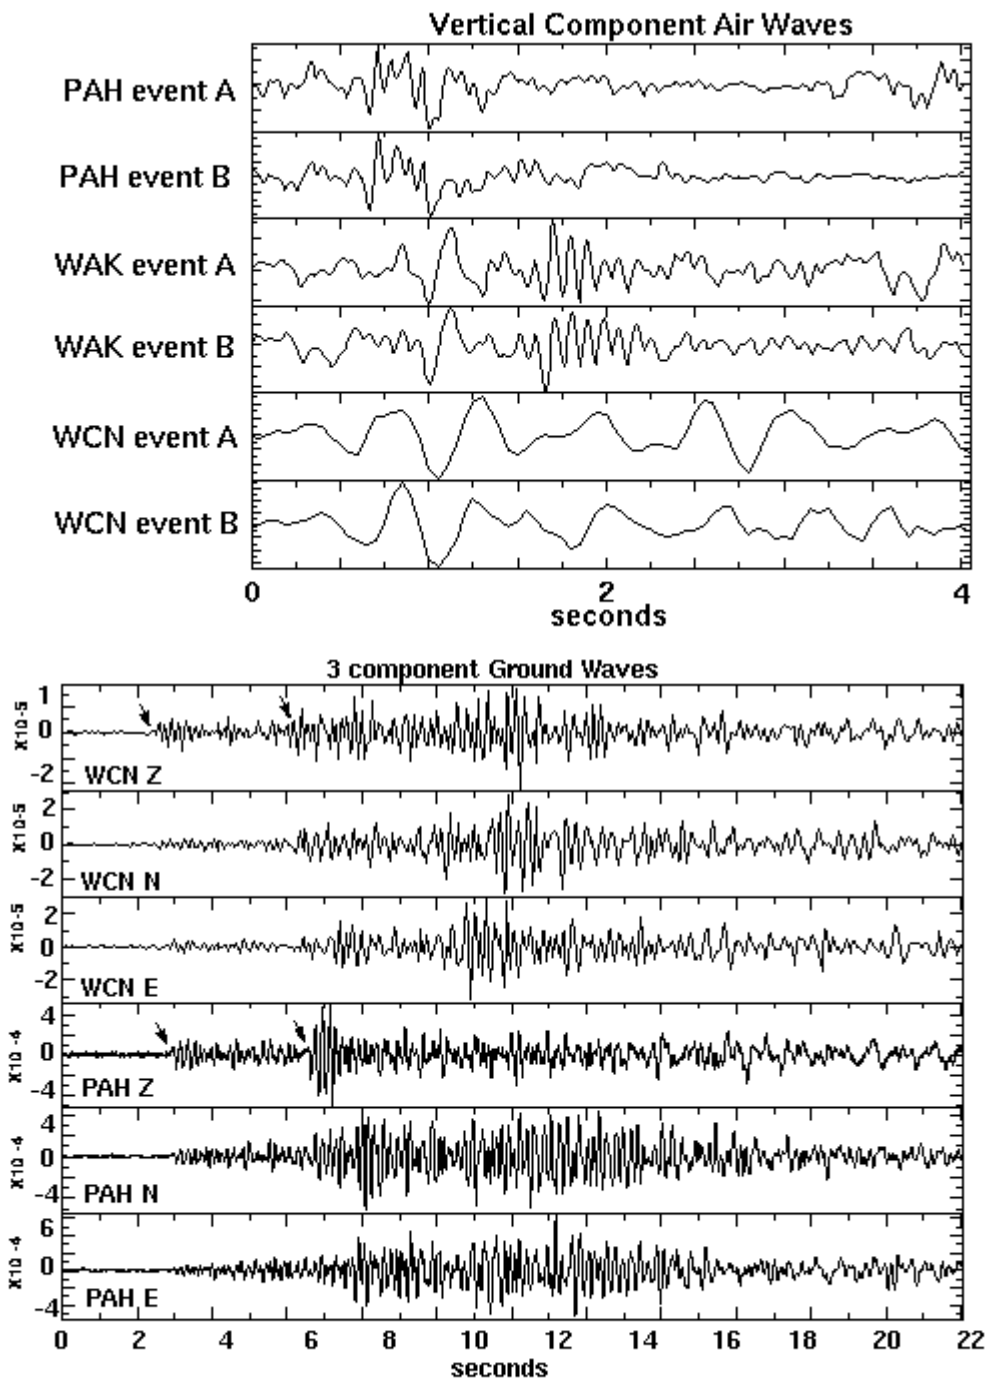
Figure 2b. Seismograms of low-passed filtered vertical component air waves and 3 component seismic waves used in this analysis. The arrows point to the arrival of P-wave of explosion A and B.

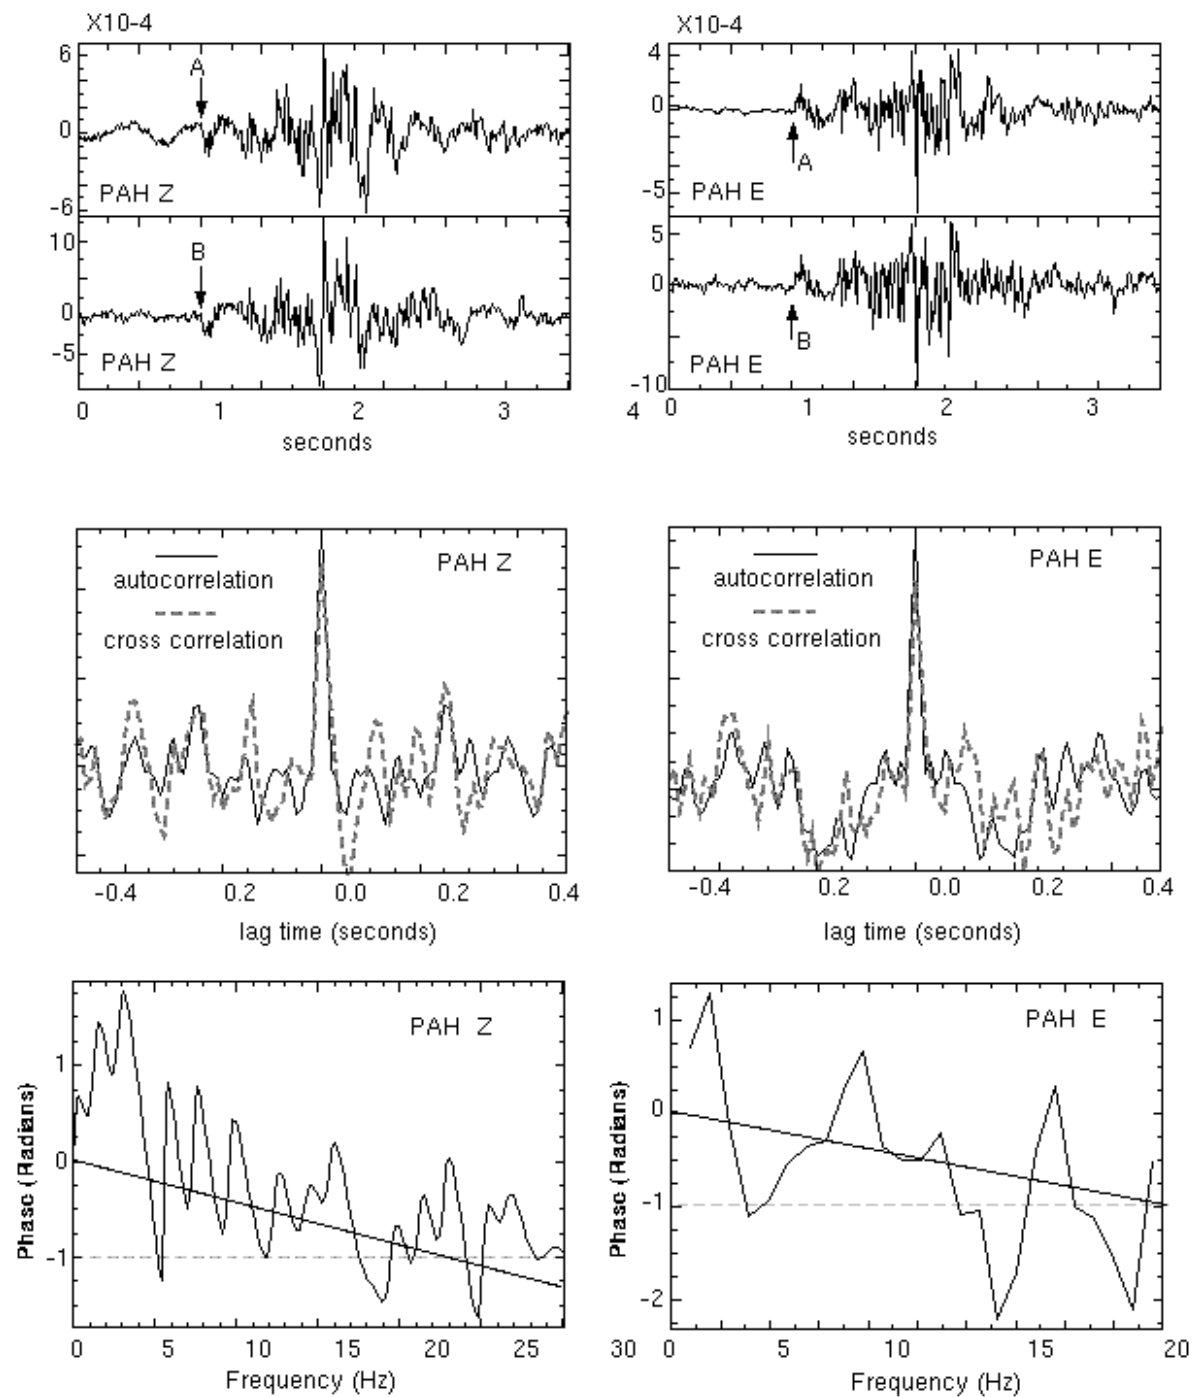
Figure 3.

The vertical and east-west component of air-waves recorded from PAH with the cross- and auto-correlation functions. The bottom panels show the slope of the phase of the cross spectrum are fit over the frequency range of > 80% coherency.

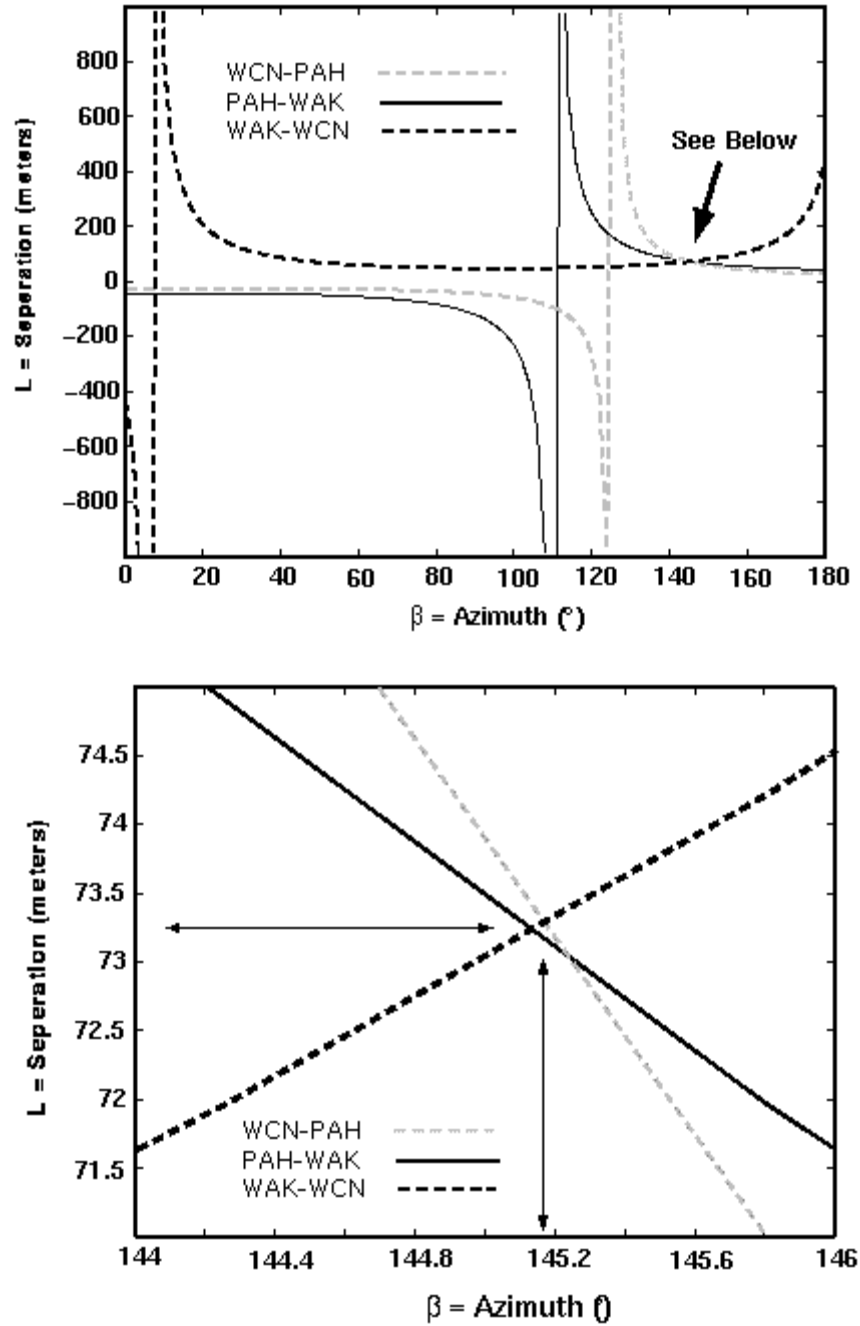
Figure 4. A plot of L , the source separation versus β , the azimuth between sources. The arrows point to the best solution for L and β .

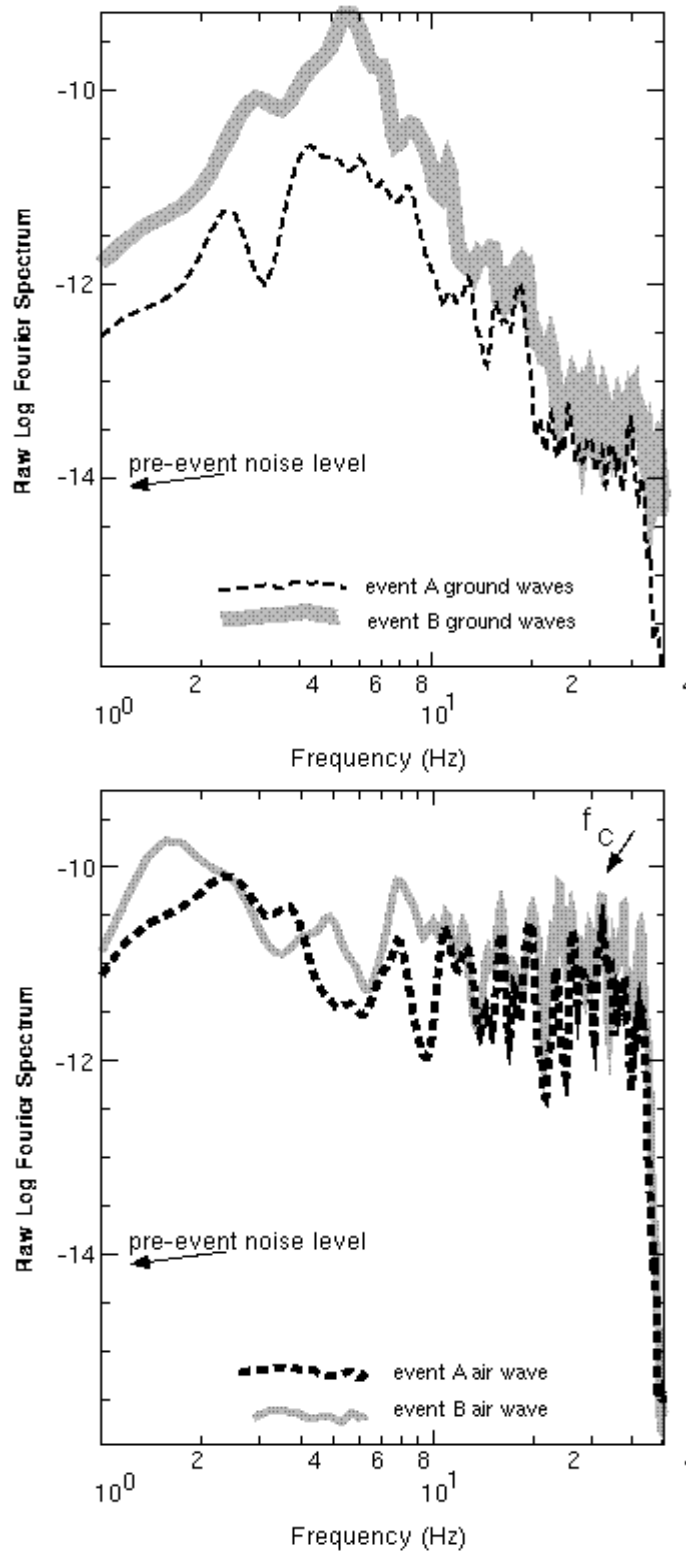
Figure 6 shows the uncorrected spectra of the P-wave and the air-wave from the two explosions at PAH (Guralp CMG-40 velocity sensor). The three components are log averaged and then smoothed. Based on the P-wave at PAH, explosion B was 3 to 4 times larger than explosion A, consistent with reports that the second site "B" contained more explosives. The spectrum of air-waves of explosion B is only a little larger than explosion A. This may suggest that explosion B was more coupled to the ground, allowing more energy to be partitioned into the ground than into the air. The CSB hypothesized that the second explosion was triggered when debris from the first explosion crashed through the ceiling or skylight at the second site. If so, we speculate that the second explosion may have been triggered at the top of the stockpile, resulting in downward directivity and a different partitioning of energy between the ground and the air.

Figure 6. Uncorrected P-wave and air-wave

The spectral curves are the smoothed log average of the three components of motion. The arrow points to peak spectral value of a noise window before explosion A.
